# Large wood as a restoration tool: I fought the law, and the law won

## *Extended abstract*

*The STREAMS Channel Protection and Restoration Conference, October 6-7, 2003, Columbus, Ohio*

F. Douglas Shields, Jr.  
USDA-ARS National Sedimentation Laboratory  
Oxford, MS 38655-1157  
dshields@ars.usda.gov

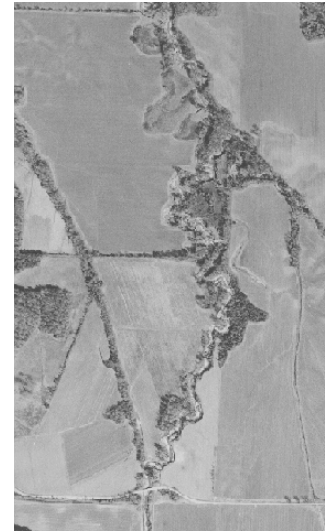
**Figure 1. Aerial view of Little Topashaw Creek prior to rehabilitation. Flow is toward the top of the photo.**

The study reach was located along 2 km of Little Topashaw Creek, a fourth-order stream in north central Mississippi (Figure 1). The surrounding watershed has been described by Simon and Thomas (2002). Contributing drainage area was about 37 km<sup>2</sup>, and floodplain stratigraphy was characterized by dispersive silt and clay soils underlain by sand overlying consolidated cohesive material. Sandy deposits were often found along the bank toe. The channel had an average sinuosity of 2.1, an average width of about 35 m, and an average depth of 3.6 m. Channel bed materials were primarily medium sand (0.2 mm < D<sub>50</sub> < 0.3 mm). However, cohesive materials occurred as massive outcrops and as gravel-sized particles. Available evidence suggested that mean width had increased by a factor of 4 to 5 between 1955 and 1999. A geomorphic evaluation performed immediately prior to construction indicated that the downstream end of the reach was in the aggradational stage V of the Simon (1989) conceptual model of incised channel evolution, while the middle part of the reach was stage IV, and the upstream fourth of the reach was still degrading (stage III). A knickpoint was located between zones classified as stage IV and stage III, with thalweg slopes ~0.003 upstream of the knickpoint and ~0.002 downstream. In general, concave banks on the outside of meander bends were failing by mass wasting and sand was accreting on large point bars opposite failing banks. Outside of bends, eroding banks were

invading adjacent cultivated fields, while inside bends and abandoned sloughs were vegetated with a diverse mixture of hardwood trees and associated species. Surveys of 13 cross sections before and after a flow of  $55 \text{ m}^3\text{s}^{-1}$  that occurred three months prior to construction indicated an average increase in cross-sectional area of 10% with bank retreat as great as 7.6 m. This event, in which peak stages reached mid-bank elevation, triggered 60 m of upstream migration of a 0.6-m high headcut and produced two chute cutoffs across point bars.

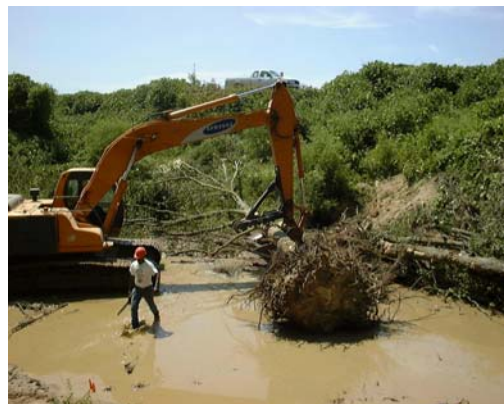
**Figure 2. Construction of LWDS. Rootwads were retained on 52% of the logs used in the structures.**

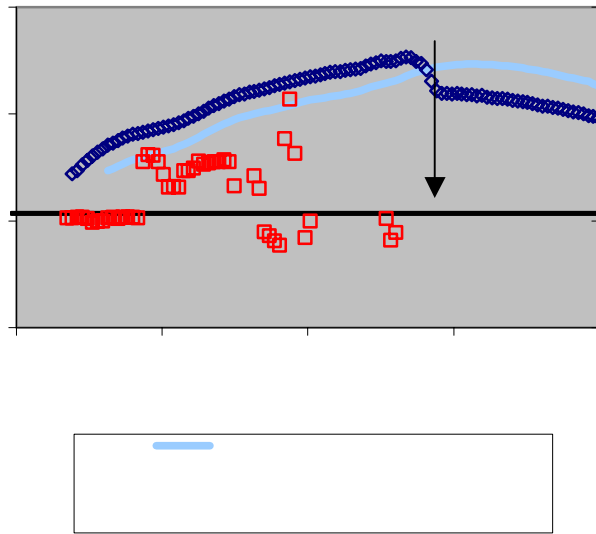
High flows during the second year following construction produced progressive failure of about a third of the large woody debris structures. Thalweg degradation in the upper one-third of the project reach caused bed lowering of ~0.3 m and dramatic erosion of point bars as the thalweg shifted toward convex banks. Structures apparently failed as velocities within the debris matrix exceeded levels needed to scour sediments deposited there. Buoyant and drag forces acting on partially decomposed LWDS members either triggered failure of earth anchors, or broke LWD into pieces short enough to float out from under the steel cables. Structures located in sharp bends were most prone to fail. Damage rates were slightly higher for anchored LWDS (20/58) than for those without earth anchors (4/14). Forty-seven percent of the anchors were located upon inspection two years after construction, and 61% of those located were not functional.

Evidently, the anchors, which were load tested when installed to 4.5 kN, were undersized. Anchor sizing was based on LWDS design dimensions and the assumption that critical conditions would occur shortly after construction. Accordingly, a relatively high value for wood density ( $0.75 \text{ g cm}^{-3}$ ) was used in computing buoyant forces. Retrospective computations using as-built dimensions and wood density =  $0.45 \text{ g cm}^{-3}$  indicate factors of safety well

below unity.

It was assumed that sediments deposited within the LWDS would add ballast to counteract the increased buoyant force associated with drying of the wood as the structure aged. However, in many cases, sediments deposited during the first high flow season were scoured during the second. Acoustic Doppler velocity loggers (Shields et al. 2001b) recorded depth and velocity within and adjacent to an LWDS located at the apex of a bend with a ratio of top width to bend radius  $\sim 1.0$ . During the rising limb of a large flow event about 16 months after construction, part of the structure apparently shifted, allowing velocities within the structure to rapidly increase from  $0.2$  to  $1.2 \text{ m s}^{-1}$ . Velocities within the LWDS then greatly exceeded the critical level for the sandy bed material and approached the velocity recorded at the adjacent channel centerline (Figure 3). Sediments deposited within the LWDS acting as ballast were scoured away, leading to a rapid decline in the factor of safety (ratio of buoyant forces to the sum of the weight of wood, sediment, and forces due to earth anchors) and failure of the LWDS.

**Figure 3. Flow depth and velocity records for an LWDS during high flow event. Vertical arrow shows time at which LWDS failed.**
